WL-TR-91-4032
DOT/FAA/CT-91/23
VOL II, Part 2

COMPOSITE FAILURE ANALYSIS HANDBOOK
VOL II - TECHNICAL HANDBOOK
PART 2 - ATLAS OF FRACTOGRAPHS

R.J. Kar
Northrop Corporation
One Northrop Avenue
Hawthorne, California 90250-3277

February 1992

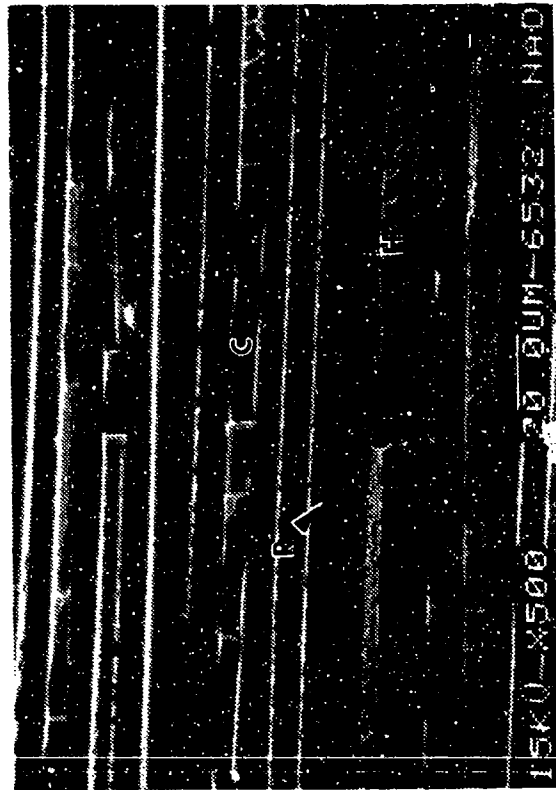
Figure 6-4. Optical and SEM Photographs of Mode I and Mode II MMF Interlaminar Fracture in AS4/5250-3 Gr/BMI - [0]₂₄. Room Temperature Ambient
(a) Macrophotograph Showing Regions I, II, and III (Precrack, Crack-Growth, and Laboratory Overload)
(b) River Patterns (R) in Initiation Region in Precrack
(c) Rivers (R), Hackles (H) and Cusps (C) in Crack-Growth Region

Figures 6-1 through 6-4 provide interlaminar fractographs and Figures 6-5, 6-6 and 6-7 provide translaminar fractographs. This contribution was made by Northrop.

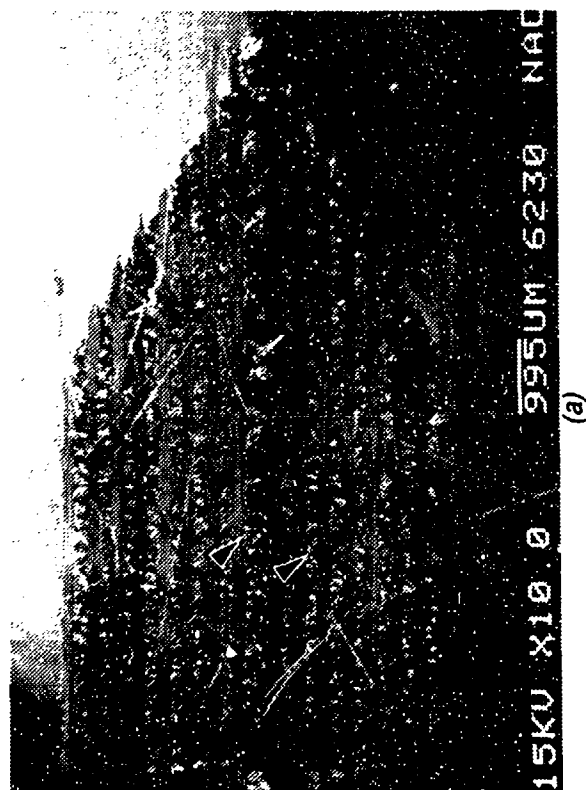
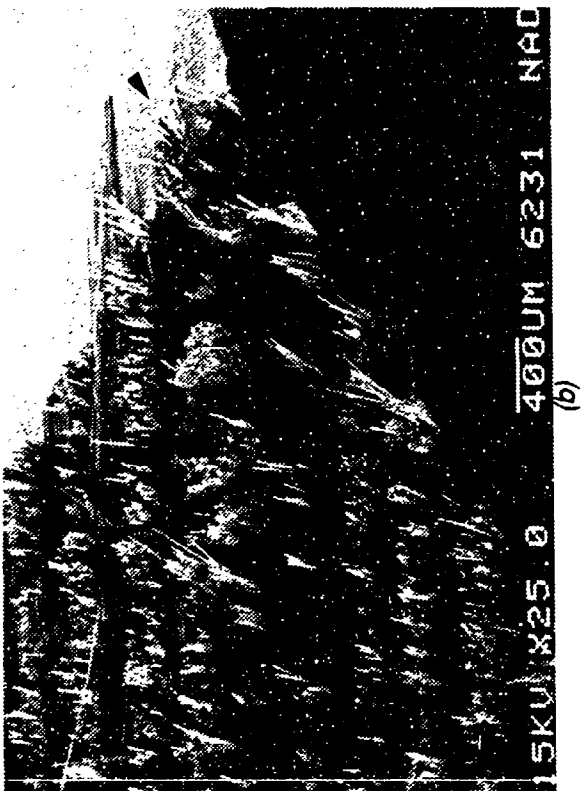
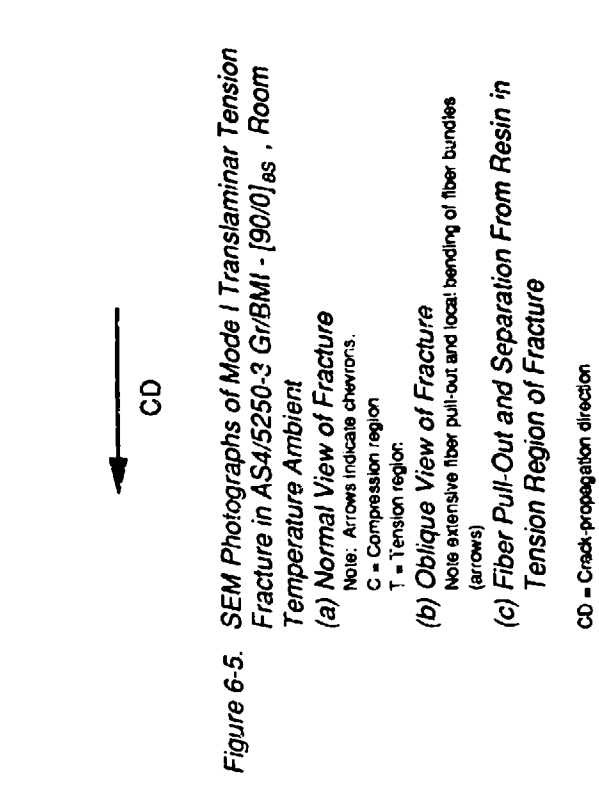
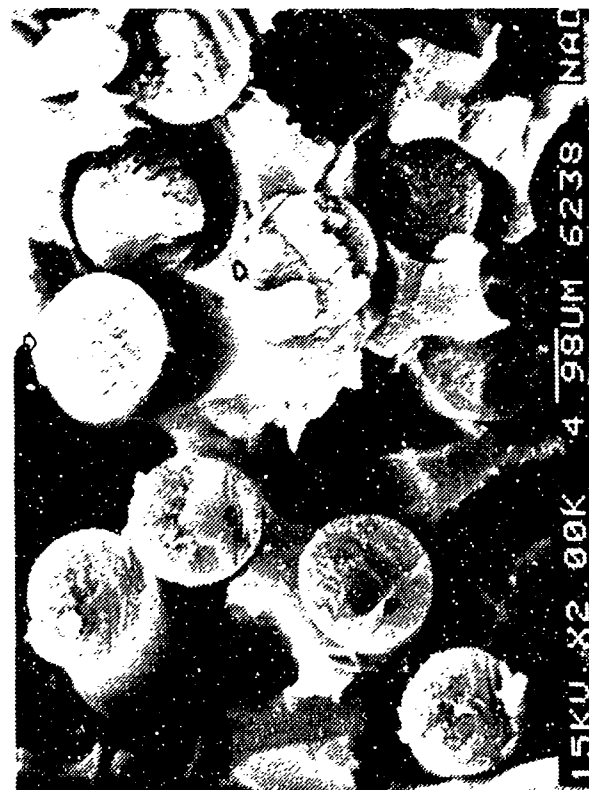
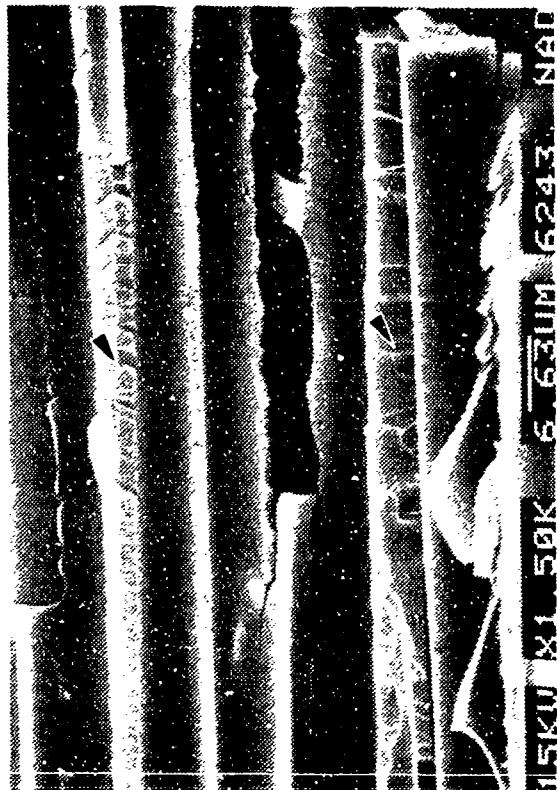
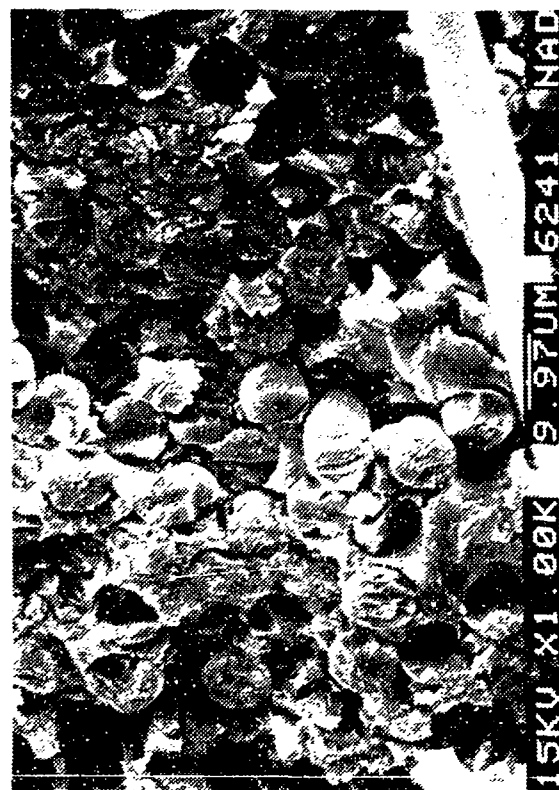
Figure 6-5. SEM Photographs of Mode I Translaminar Tension Fracture in AS4/5250-3 Gr/BMI - [90/0]_{as}, Room Temperature Ambient

(a) Normal View of Fracture
Note: Arrows indicate chevrons.
C = Compression region
T = Tension region

(b) Oblique View of Fracture
Note extensive fiber pull-out and local bending of fiber bundles (arrows)

(c) Fiber Pull-Out and Separation From Resin in Tension Region of Fracture

(e) Resin Fracture in 90 Degree Ply (Tension Region)

(f) Chop Marks on Fiber Ends in Compression Region

The translaminar fracture features of Gr/BMI are very similar to Gr/Ep. Translaminar tension failures can be mapped by DAF radials on fractured fiber ends, as in Gr/Ep. There are no significant fracture characteristics that can be used to map crack directions in compression failures.

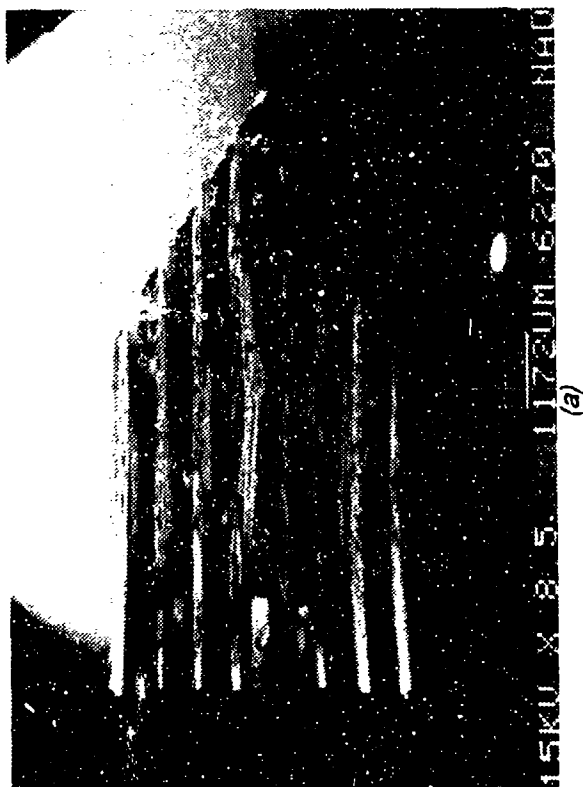
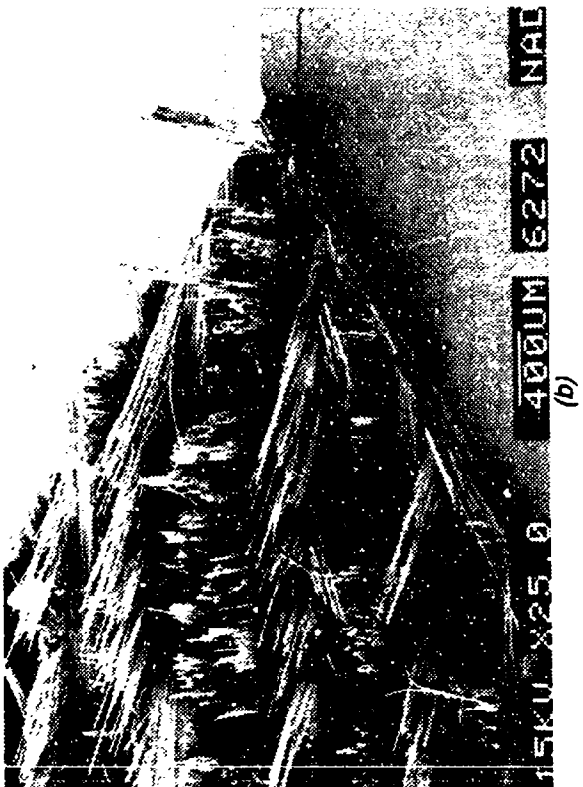
Figure 6-6. SEM Photographs of Mode I Translaminar Tension Fracture in AS4/5250-3 Gr/BMI - 32 Ply Quasi-Isotropic, Room Temperature Ambient

(a), (b) Normal and Oblique Views of Fracture

(c) DAF Radials (Arrows) on Fractured Fiber Ends (0 Degree Ply, Tension Region)

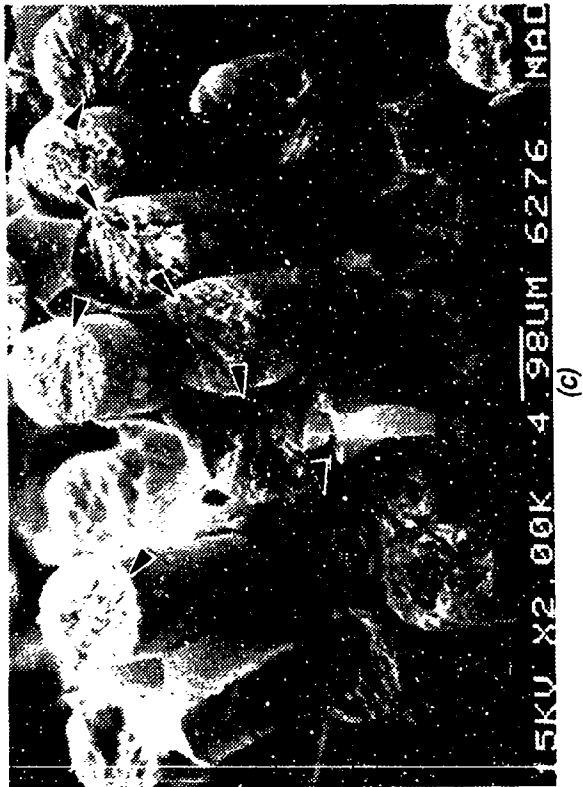
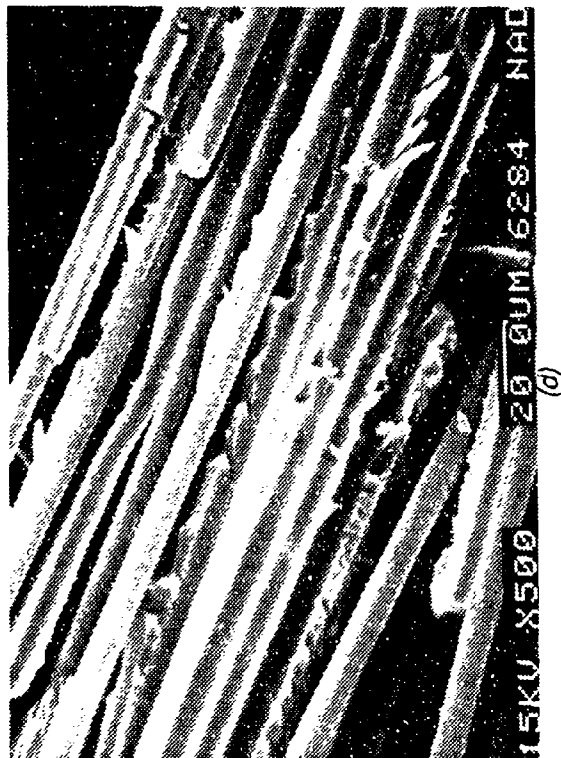
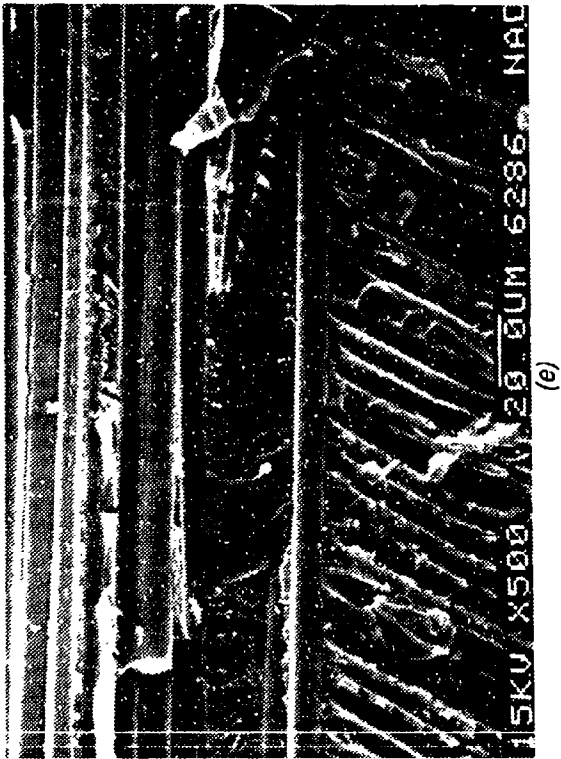
Figure 6-6. (Continued)
 (a), (e) Peel Fracture in 45 and 90 Degree Plies
 (f) Chop Marks (Arrows) on Fiber Ends in
 Compression Region

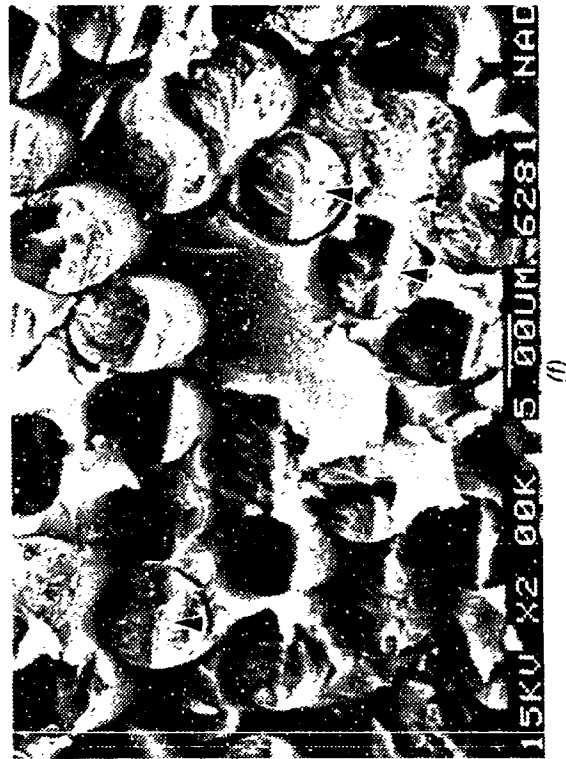
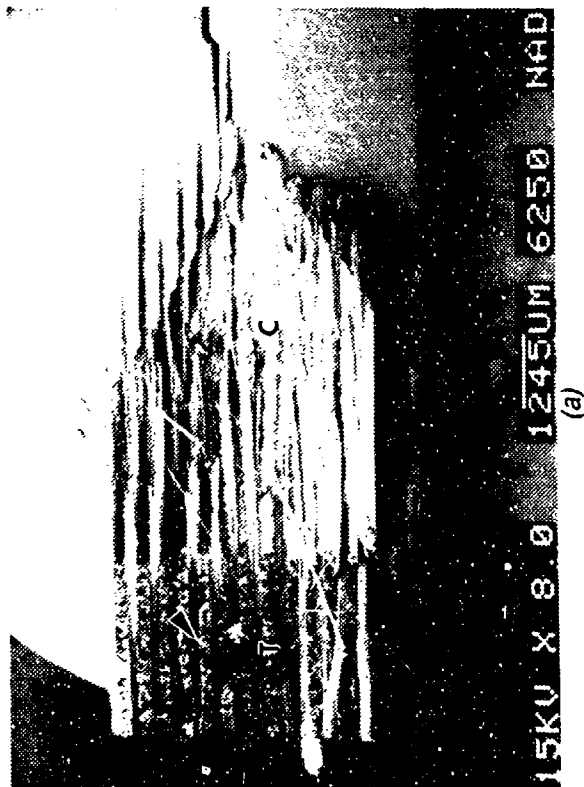
Figure 6-7. SEM Photographs of Mode I Translaminar Compression Fracture in AS4/5250-3 Gr/BMI - [90/0] _{gs}, Room Temperature Ambient

(a) Normal View of Fracture
 Note: Arrow indicates chevrons.
 C = Compression region
 T = Tension region

(b) Oblique View of Fracture
 Note: longitudinal splits close to apex of notch (arrow)

(c) Chop Marks on 0 Degree Fiber Ends in Compression Region

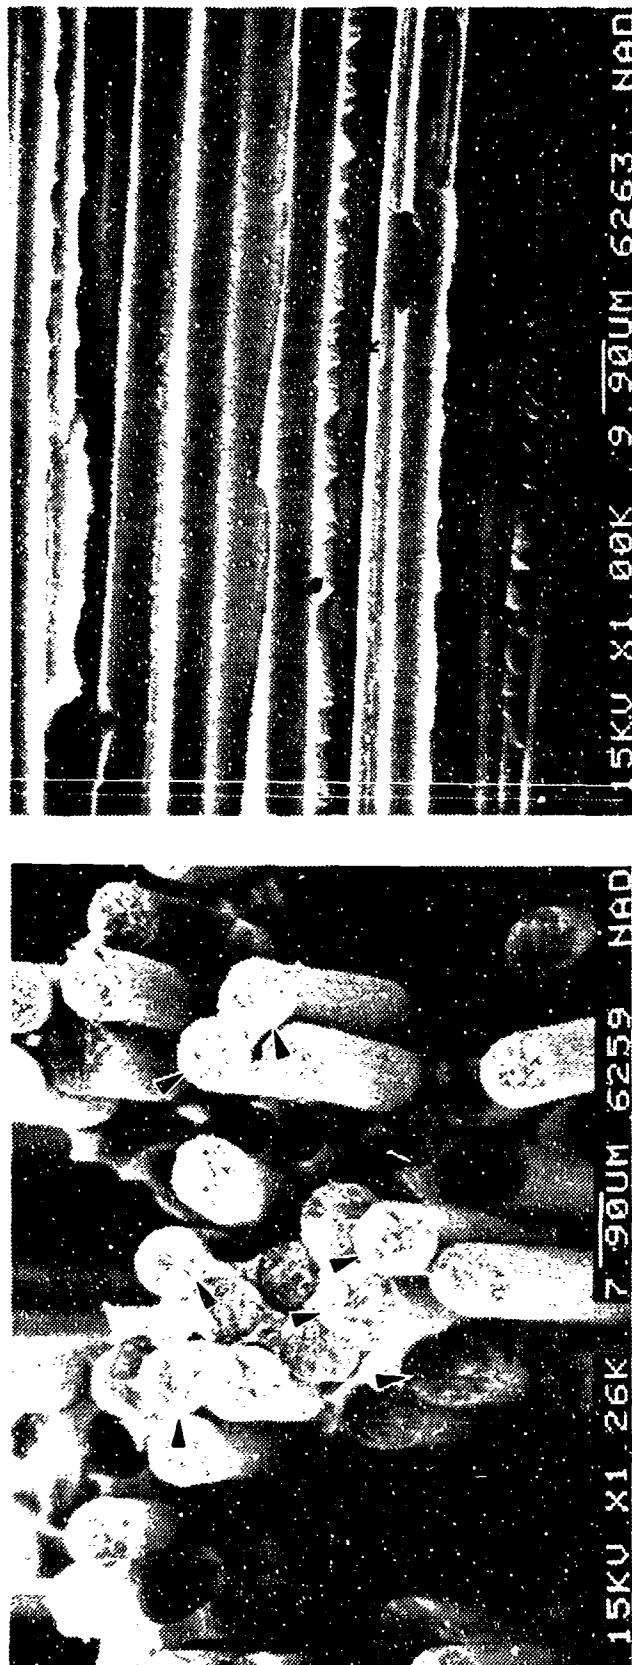
Figure 6-7. (Continued)
 (d) DAF Radials (Arrows) on Fractured Fiber Ends in Tension Region
 (e) Fracture Features Present in 90 Degree Ply Oriented Parallel to Fracture
 H = Hackles
 R = River patterns
 CD = Crack-propagation direction

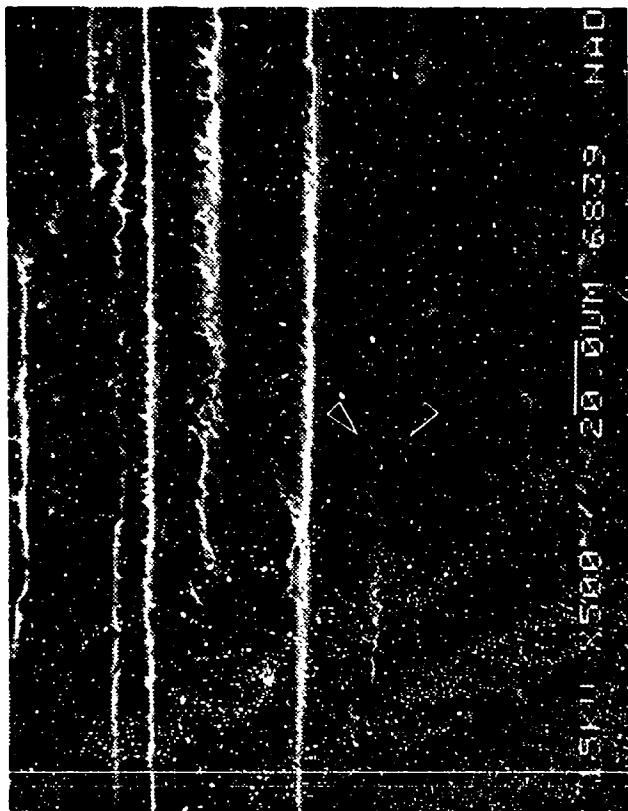
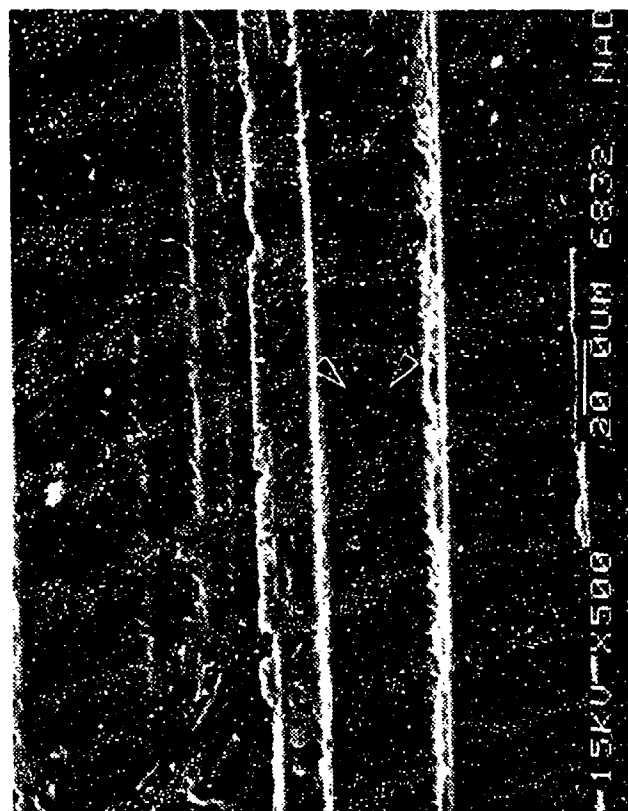
Figure 7-1. (Continued)
(c), (d) Mating Fracture Surfaces Showing Fractured Fibrils (Arrows)

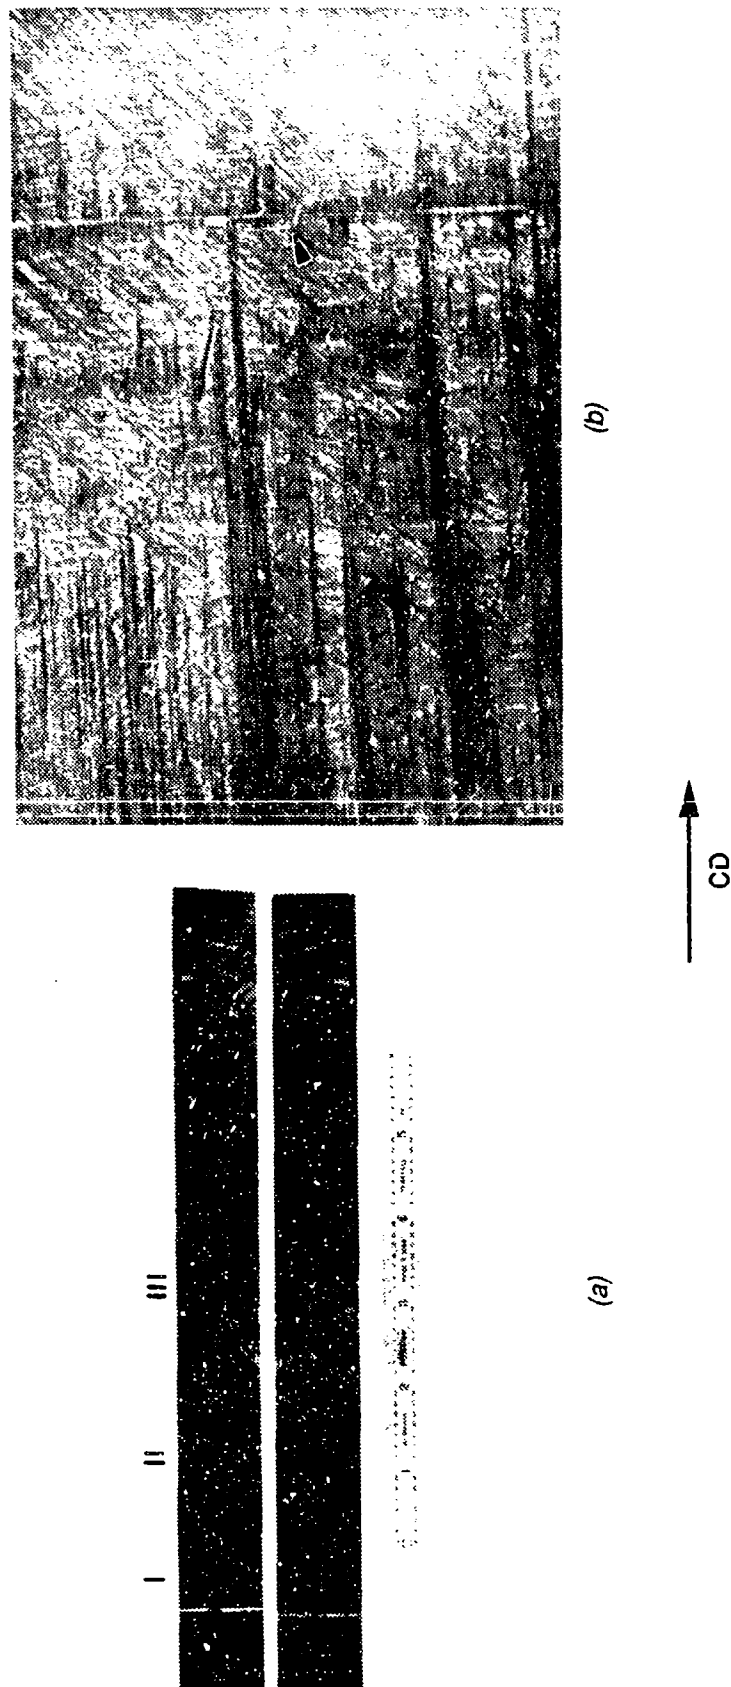
Figure 7-2. Optical and SEM Photographs of Mode I DCB Interlaminar Fracture in AS4/APC-2 Gr/PEEK - [+45/0/-45]_{4s}, Mode I DCB, Room Temperature Ambient
(a) Macrograph Showing Regions I, II, and III
(b) Ribbs (Arrows) Oriented Toward CD

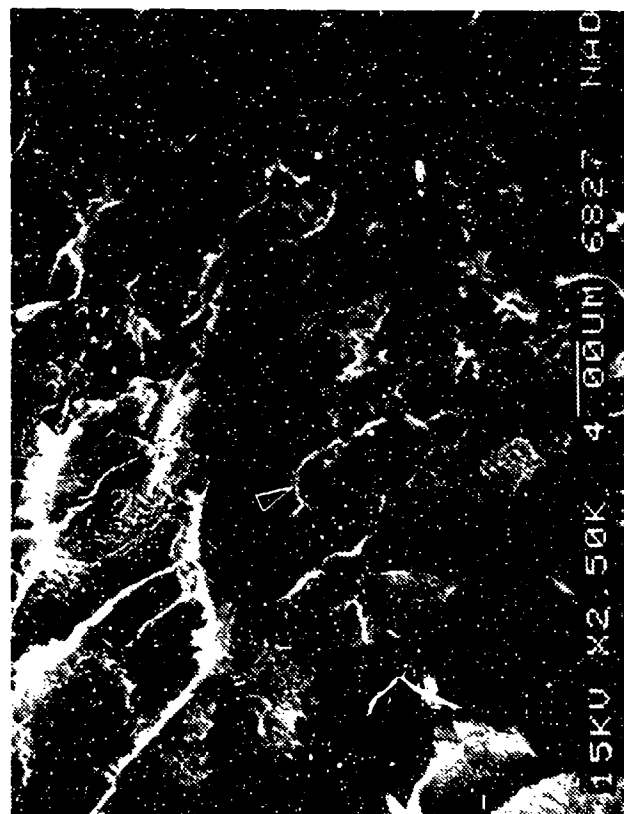
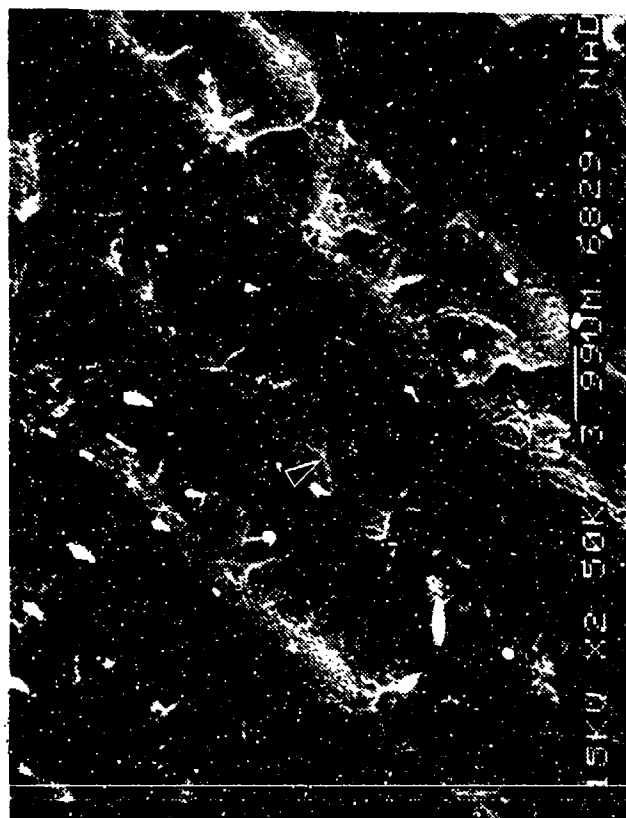
Figure 7-2. (Continued)
(c), (d) Mating Fracture Surfaces Showing Fractured Fibrils (Arrows)

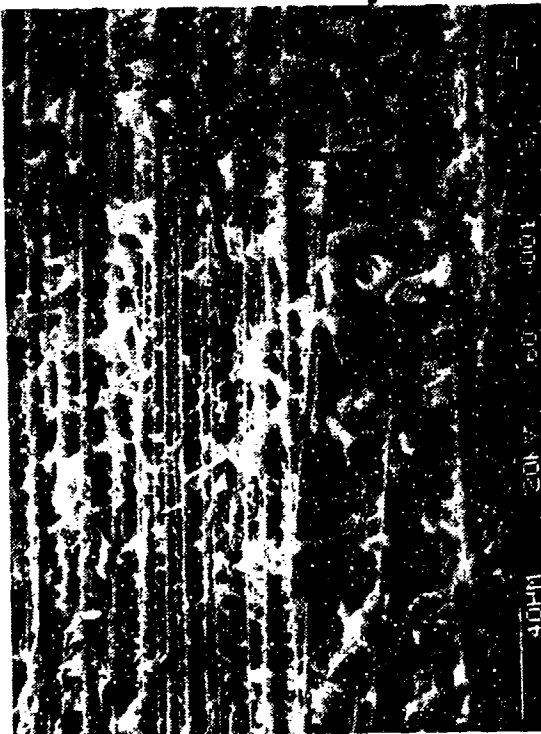
Legend:
 D ductile matrix fracture
 F fiber
 Mechanically induced crack direction

Figure 7-3. SEM Fractographs of 270/F Wet, Interlaminar Mode I Tension, 0/90 Fracture in AS4/APC-2

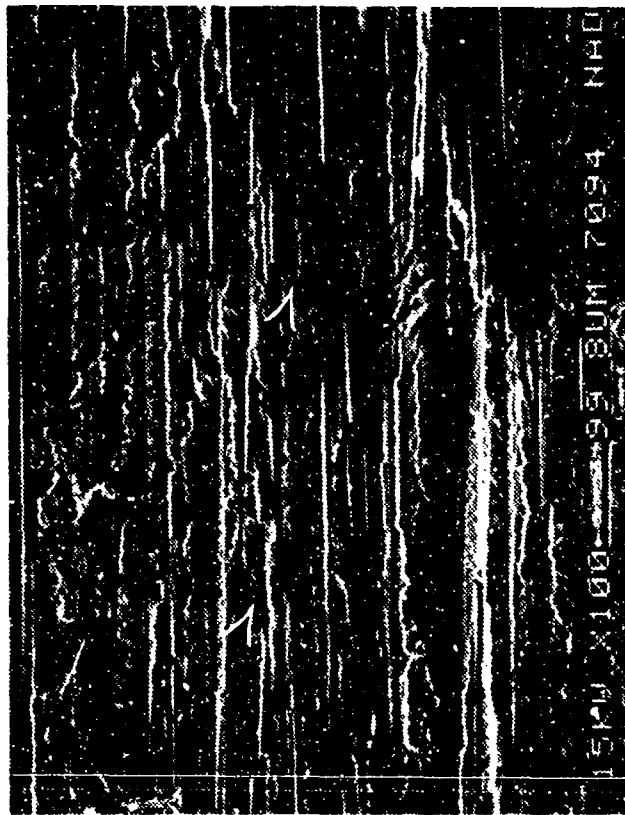
Figure 7-4. Optical and SEM Photographs of Mode I DCB Interlaminar Tension Fracture in AS4/APC-2 Gr/PEEK - [0]_{24T}, Conditioned 180 F/Dry
(a) Macro photograph of Fracture Showing Regions I, II, and III
(Precrack, Crack-Growth, and Laboratory Overload)
Note: Arrows indicate ribs oriented toward CD.

(b) Ribs (Arrows)

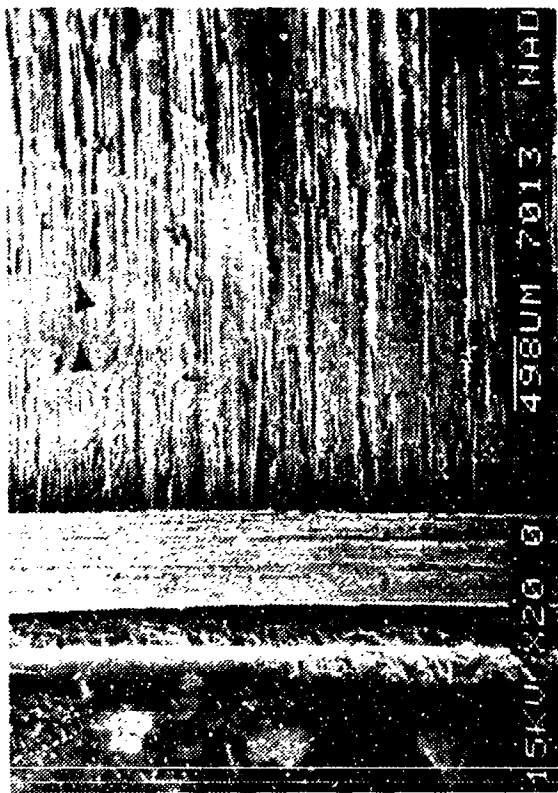
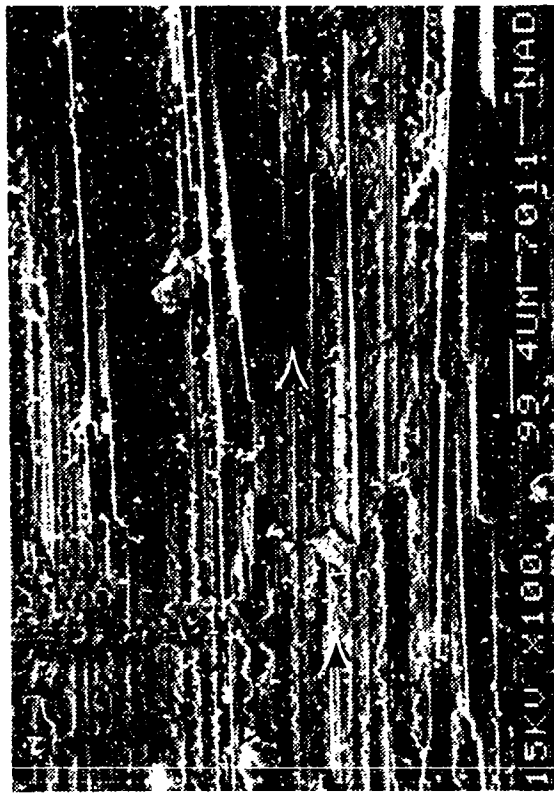
Figure 7-6. Optical and SEM Photographs of Mode I DCB Interlaminar Tension Fracture in AS4/APC-2 Gr/PEEK - [90/0]_{6s}, Conditioned 180 F/Dry

(a) Macro photograph of Fracture Showing Regions I, II, and III (Pre-crack, Crack-Growth, Laboratory Overload)

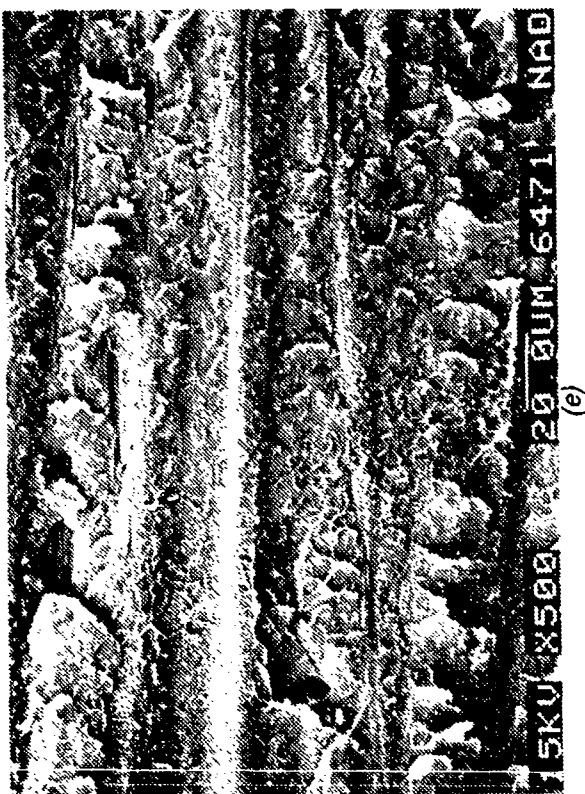
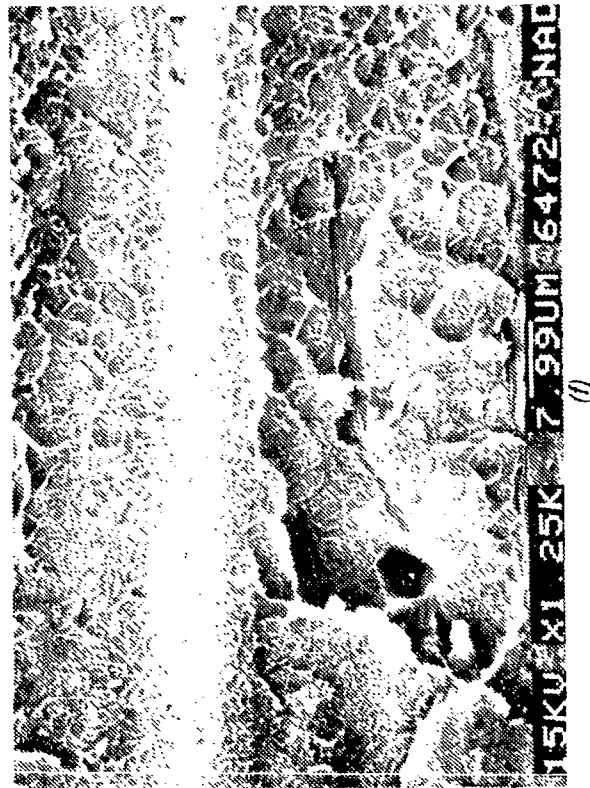
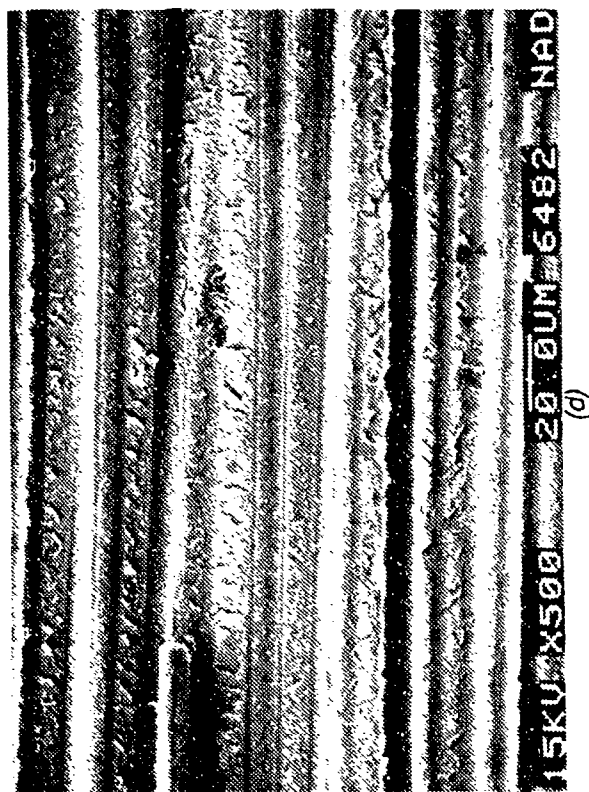
Figure 7-7. (Continued)
 (d), (e) Region I Fracture
 (f) Peel Fracture in Region I
 CD = Crack-propagation direction

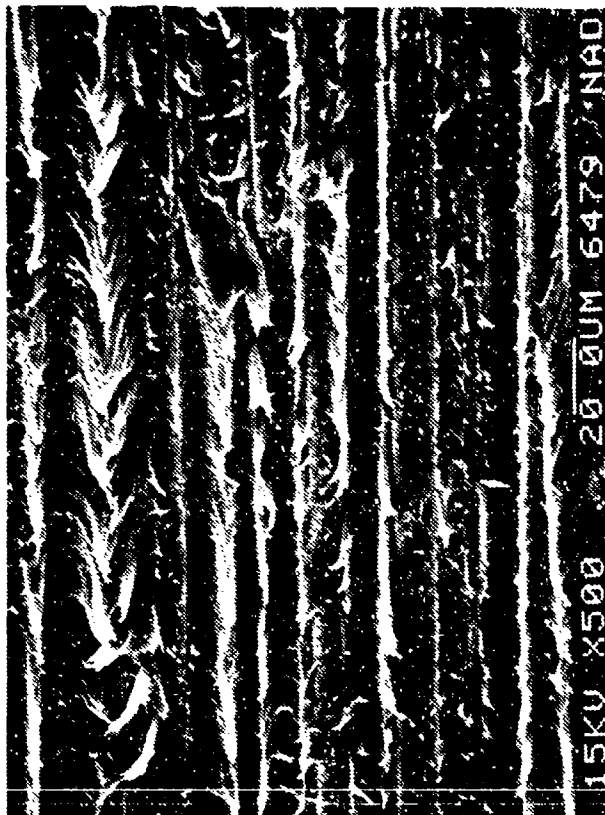
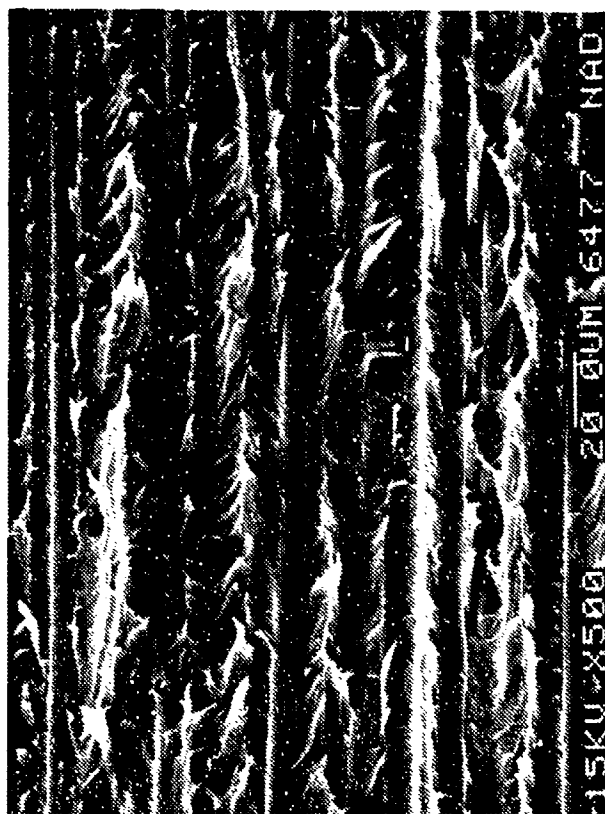
Figure 7-7. (Continued)
(g), (h) Shear Fracture Region in Mating Halves
Note orientation of drawn fibrils (arrows)

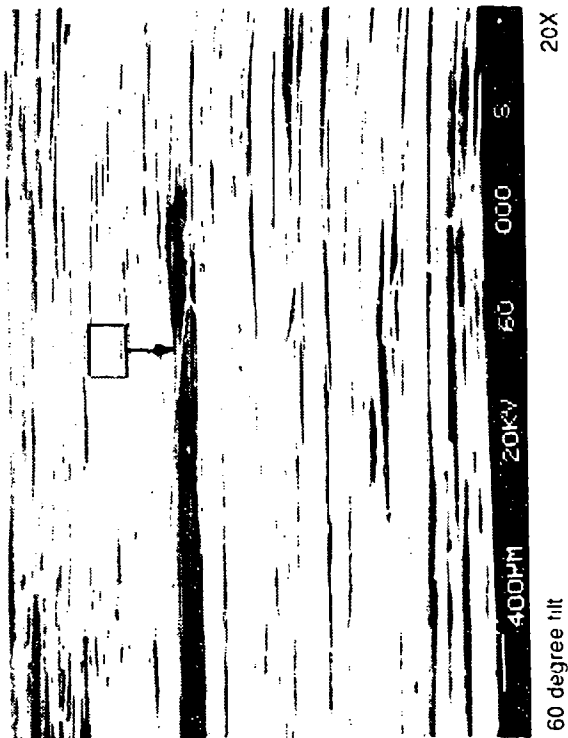
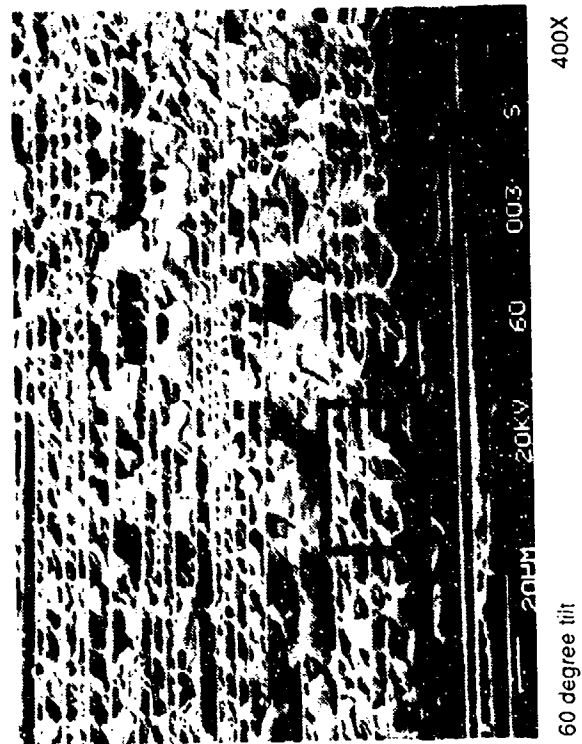
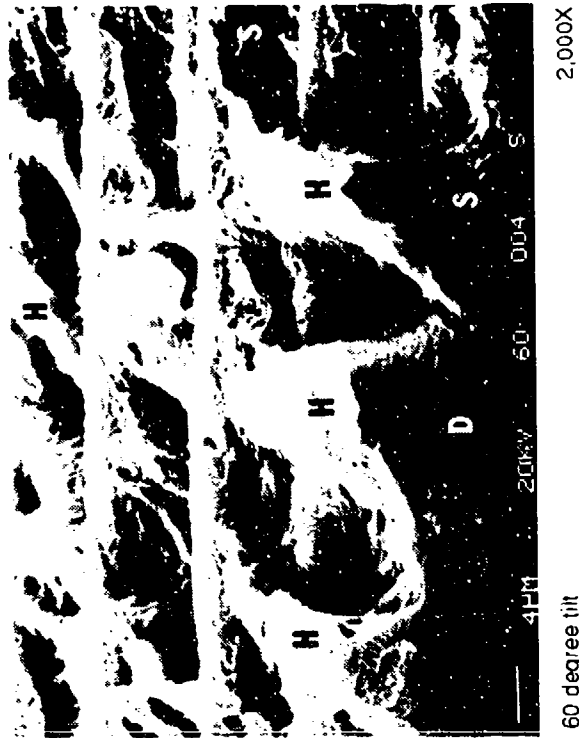
- D ductile overload
- H hackle
- S ductile shear

Figure 7-8. SEM Fractographs of 270/F Wet, Interlaminar Mode II Shear, 0/90 Fracture in AS4/APC-2

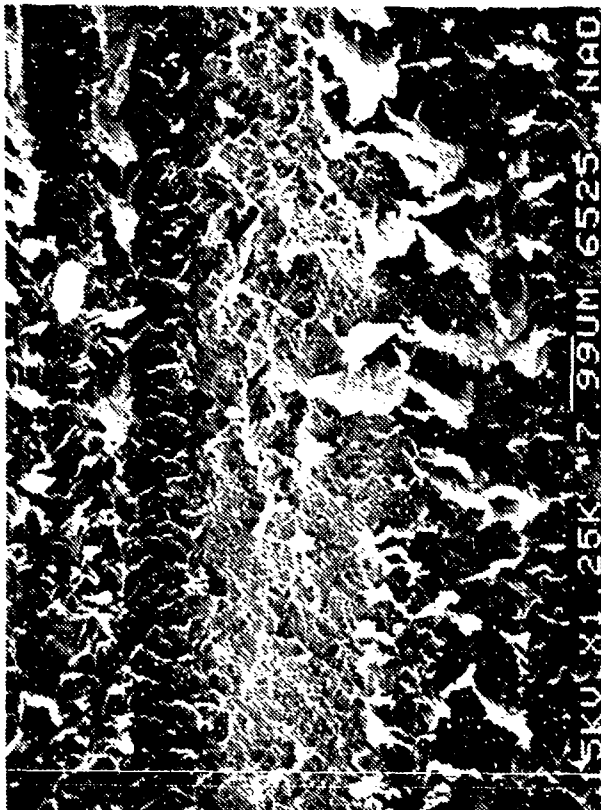
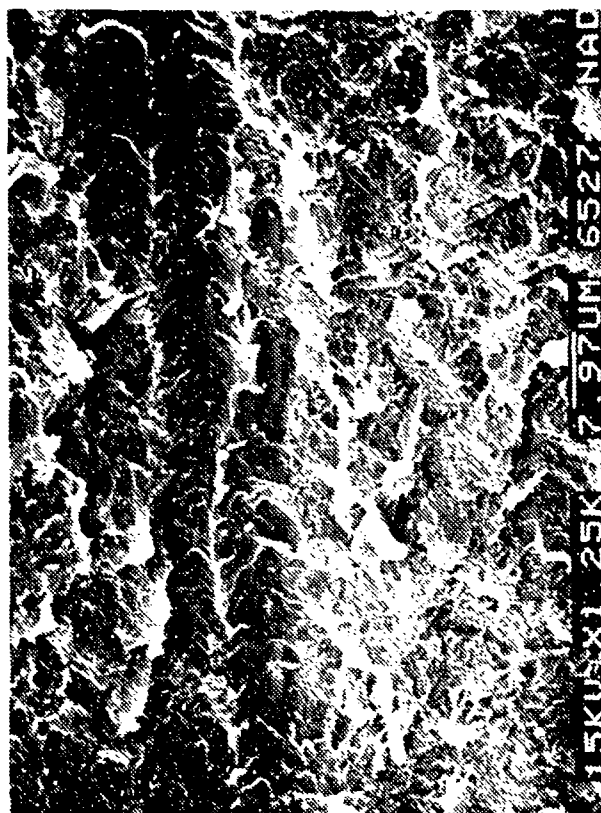
Figure 7-9. (Continued)
(c), (d) Shear Fracture Region in Mating Fracture Halves
Note orientation of drawn fibrils (arrows)

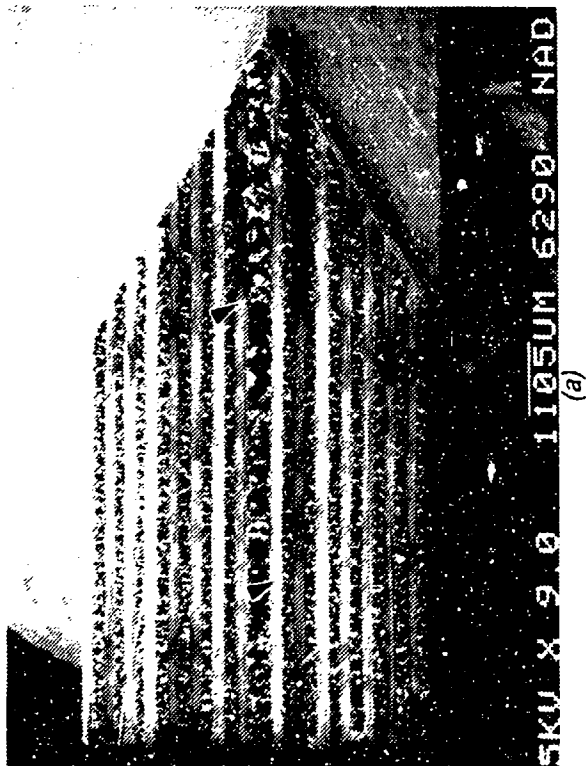
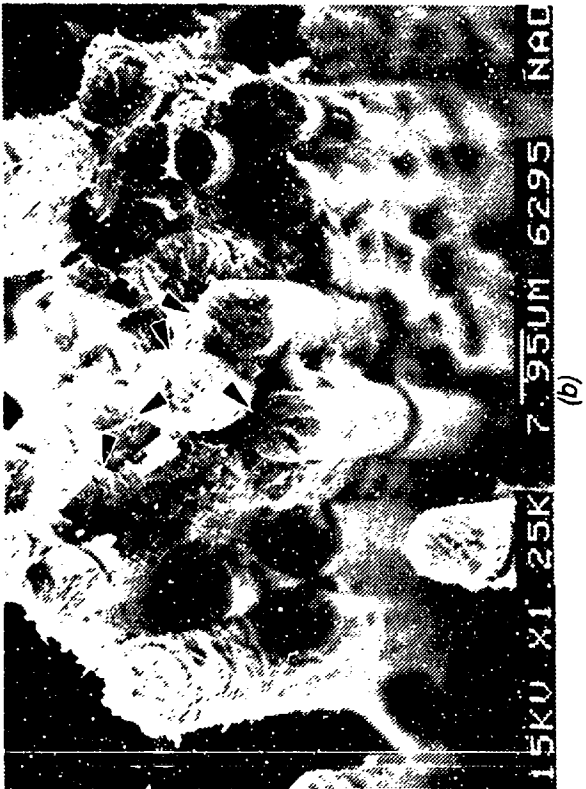
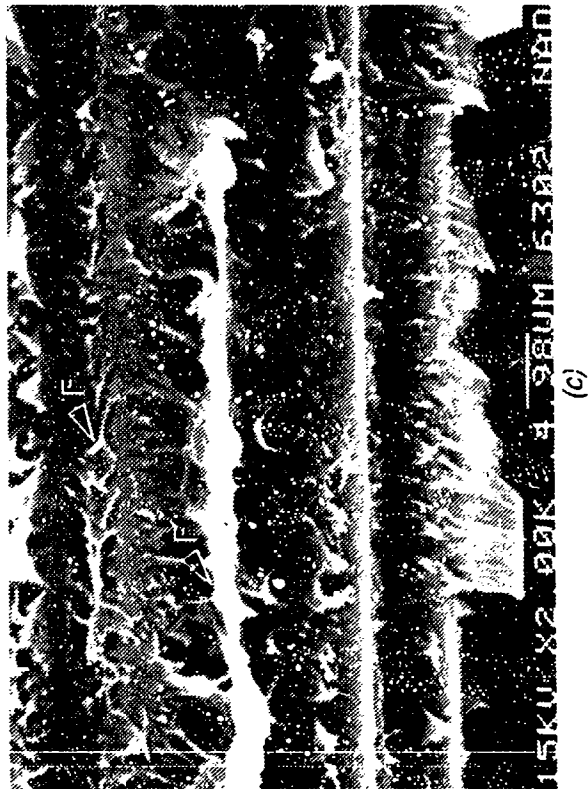
Figure 7-10. Optical and SEM Photographs of Mode I Translaminar Tension Fracture in AS4/APC-2 Gr/PEEK - [90/0] as

(a) Macrophotograph
Note: Arrows indicate chevrons.

(b) Fracture in 0 Degree Fibers (Tension Region)
Note: Arrows indicate DAF radials.

(c) Resin Fracture in 90 Degree Plies
Note: Fractured fibrils oriented along CD

CD = Crack propagation direction
F = Fibrils

Interlaminar fracture mode fractographs are provided in Figures 7-1 through 7-9 and translaminar fracture mode fractographs are provided in Figures 7-10 through 7-13.

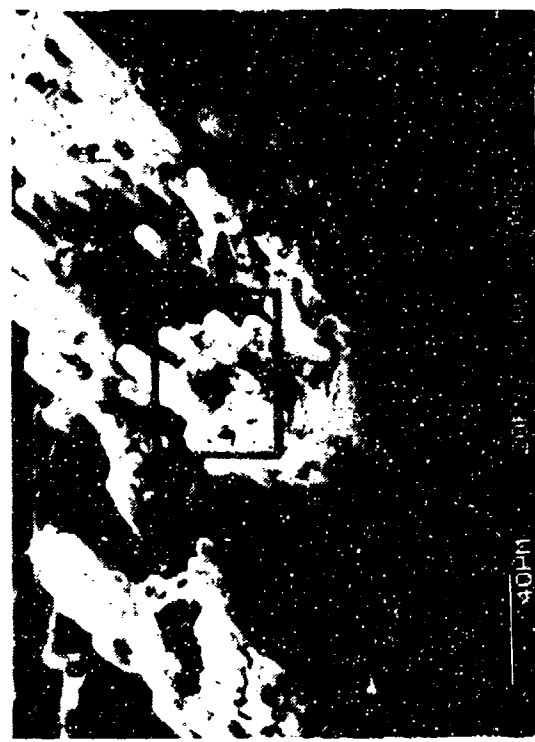
30 degree tilt 20X

0 degree tilt 400X

0 degree tilt 2,000X

Figure 7-11. SEM Fractographs of 270/F Wet, Translaminar Tension, 0/90 Fracture in AS4/APC-2

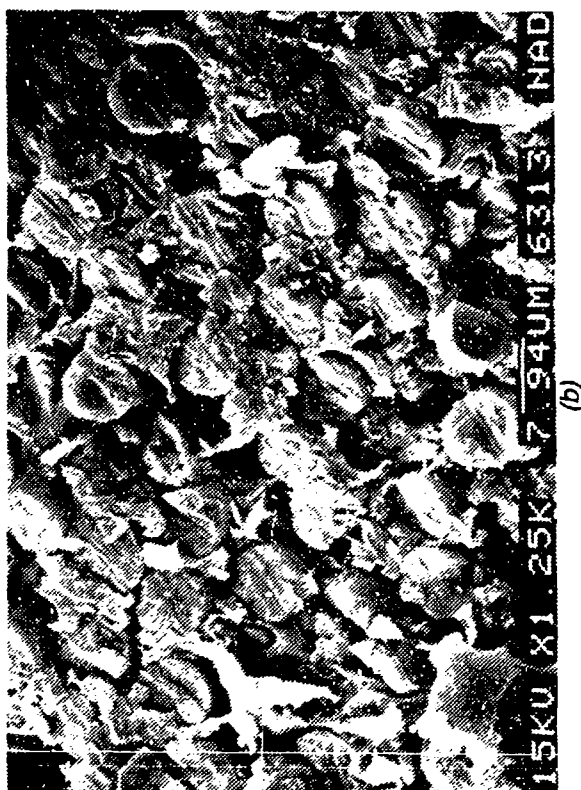
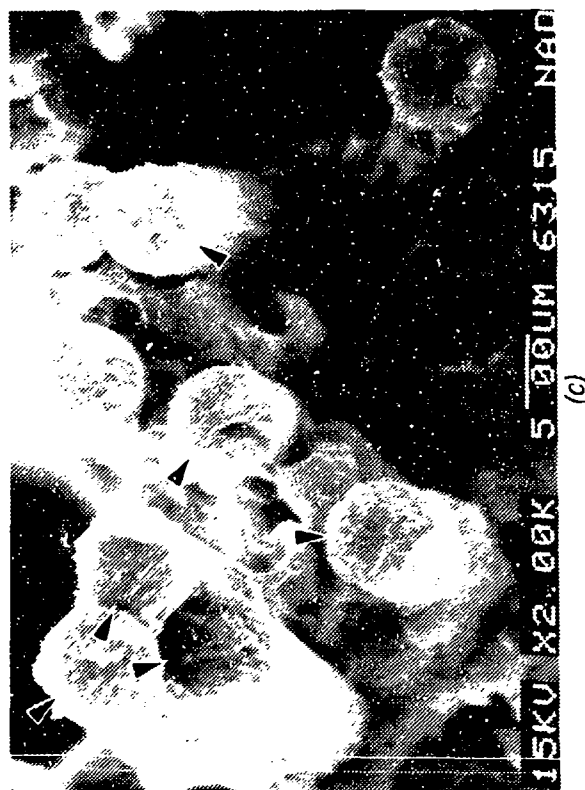
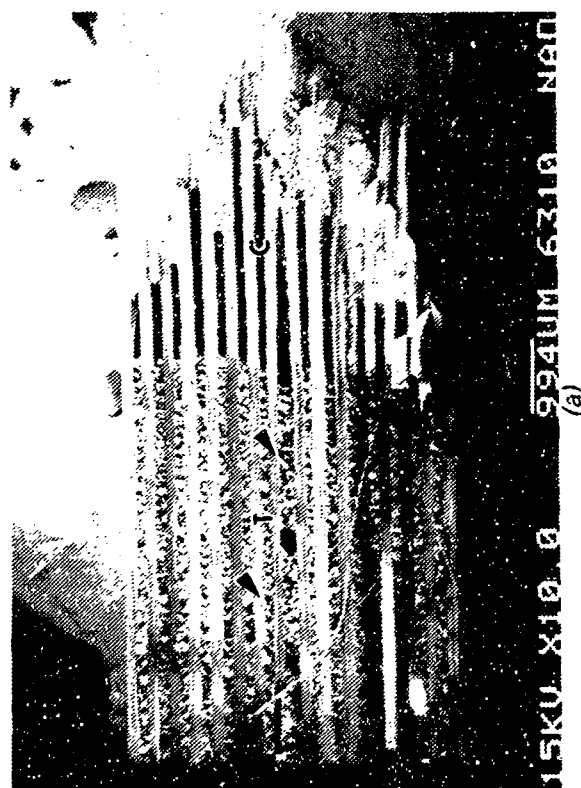
Figure 7-12. Optical and SEM Photographs of Mode I Translaminar Compression Fracture in AS4/APC-2 Gr/PEEK - [90/0]_{as}, Room Temperature Ambient

(a) Macro photograph
C = Compression region
T = Tension region

(b) Chop Marks on Fractured 0 Degree Fibers (Compression Region)

(c) DAF Radials on Fractured 0 Degree Fibers (Tension Region)

CD = Crack-propagation direction

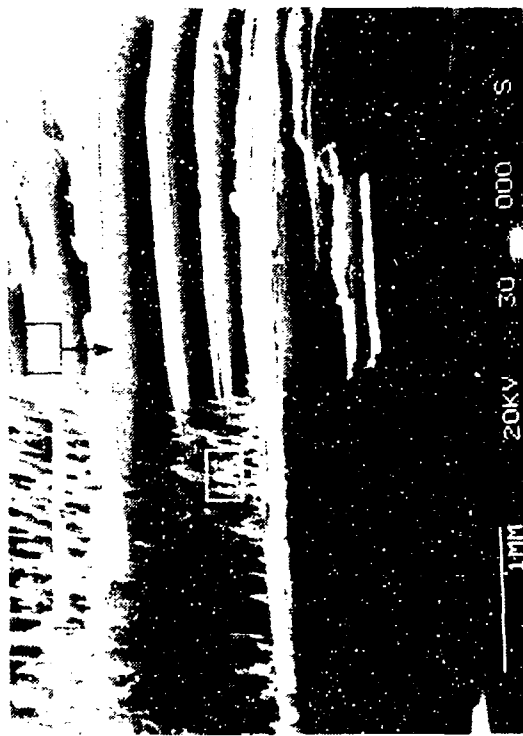
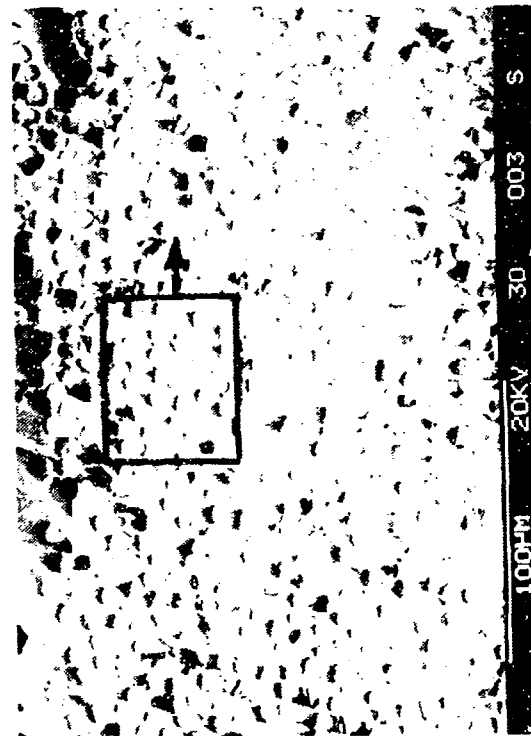
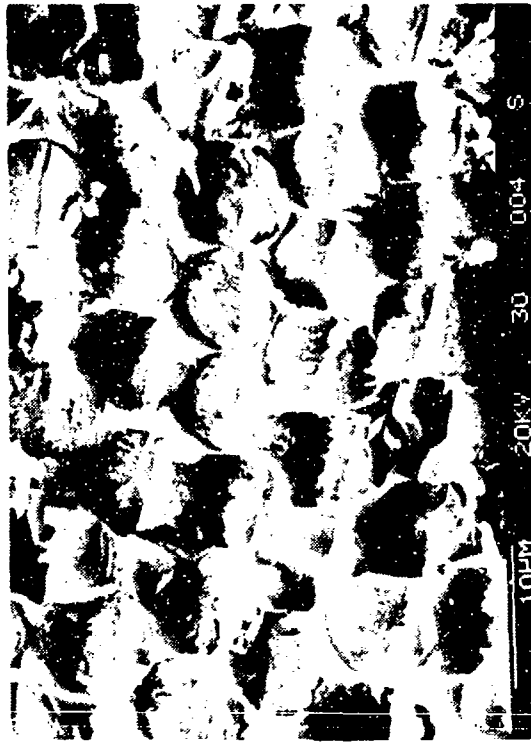
30 degree tilt

20X

400X

2,000X

Figure 7-13. SEM Fractographs of 270/F Wet, Translaminar Compression, 0/90 Fracture in AS4/APC-2
